Building Survey

John Smith
1 Anystreet
Abytown
Anywhere
DN29 9AD

Date: 07/12/2023**Report ID:** 8265A**Property:**1 Anystreet
Abytown
Anywhere NOT DN29 9AD**Customer:**

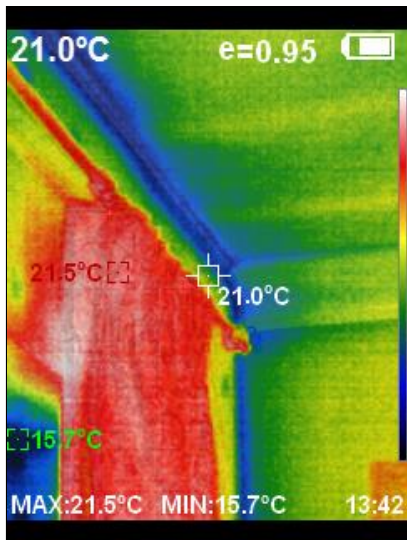
3.2 Item 1(Picture) Cold bridging is at normal levels

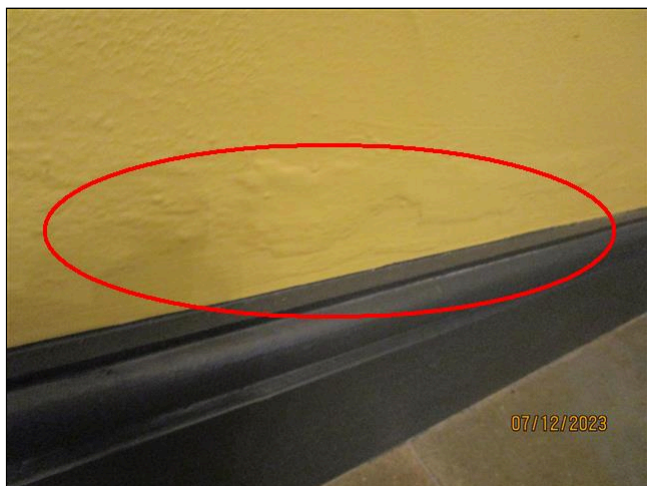
I did note some blistering to the plaster and some high moisture readings to the internal wall between the Hall and the Kitchen.

Given the age of the property, and the fact that there is no DPC (Damp Proof Course) to any internal walls, some damp is to be expected. This damp seems to be a mix of condensation and possible moisture from the floor. If the wall plaster is in contact with the floor it can act as a wick drawing moisture up from the floor. There should be 75mm gap between the wall plaster and the floor to reduce the risk of damp. This gap is then covered by skirting boards.

The condensation here may be due to the external walls being insulated. The surface temperature will be higher than the internal wall (in the cold evenings) and previously the condensation would have occurred on external walls. Now I would suspect that the condensation occurs on the windows and base of colder internal walls.

3.2 Item 3(Picture) Signs of damp at the base of the wall in Hall/Kitchen

If the damp becomes unsightly the wall can be painted with damp proof paint or a damp proof liner used.

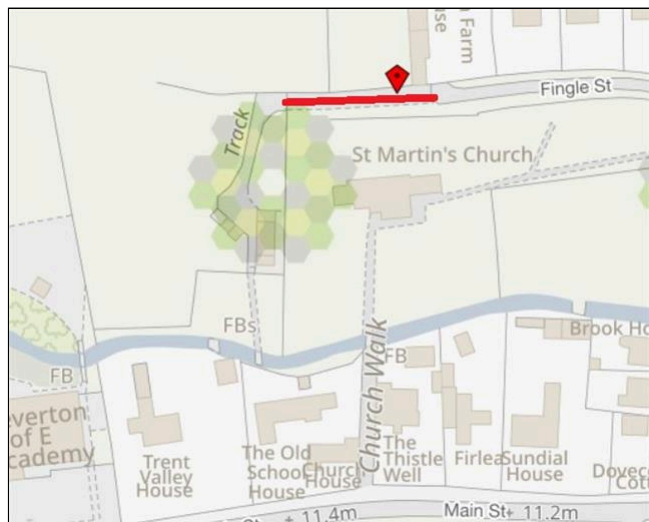
There seems to be an unadopted section of road at the rear (the end of Fingle Street) and there may be maintenance responsibilities attached to the subject property. The section of road is highlighted in Red on attached map.

6.1 Item 1(Picture) Possible unadopted road at the rear

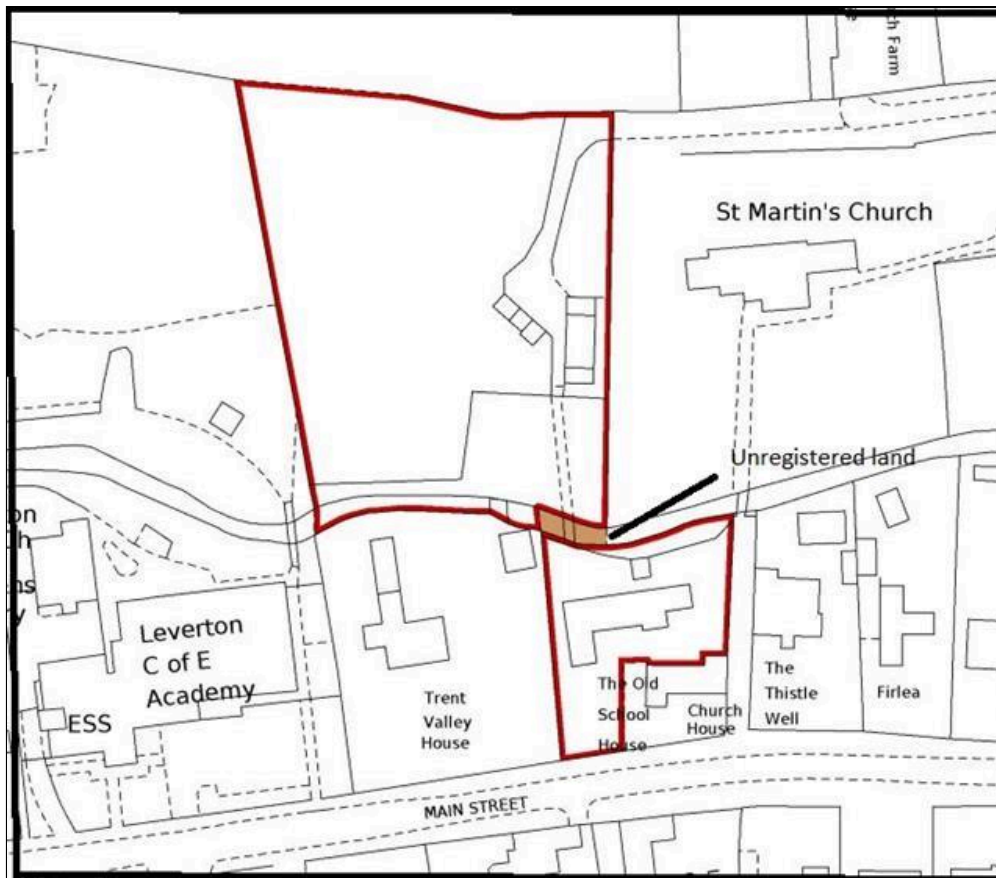
6.7 Item 2(Picture) Unregistered land in Brown

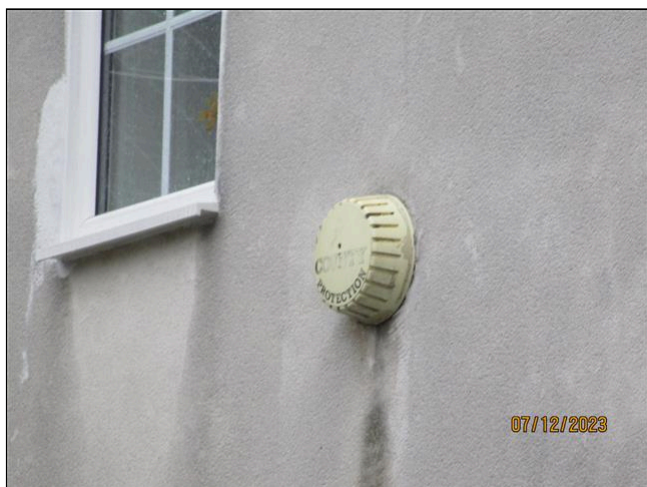
There is no intruder alarm at the property.

7.9 Item 1(Picture) Intruder alarm not tested

It is recommended that an alarm system is fitted upon occupancy.

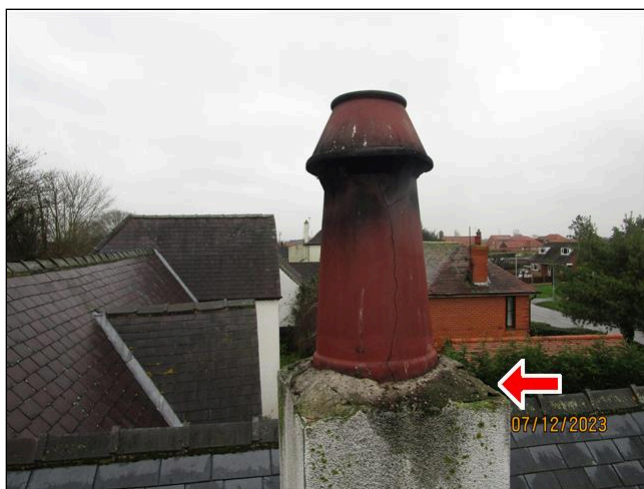
The render has a damp stain at the top and the flaunching may be cracked, allowing water ingress.

9.3 Item 1(Picture) Flaunching may have cracks

The chimney flaunching and render should be checked at this time.

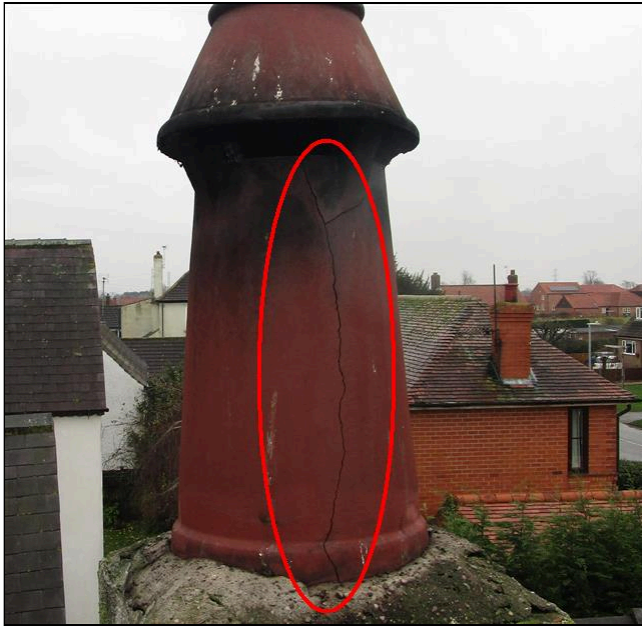
I did note that the pot was cracked t the time of inspection.

9.3 Item 3(Picture) Crack to the chimney pot

The pot should be replaced.

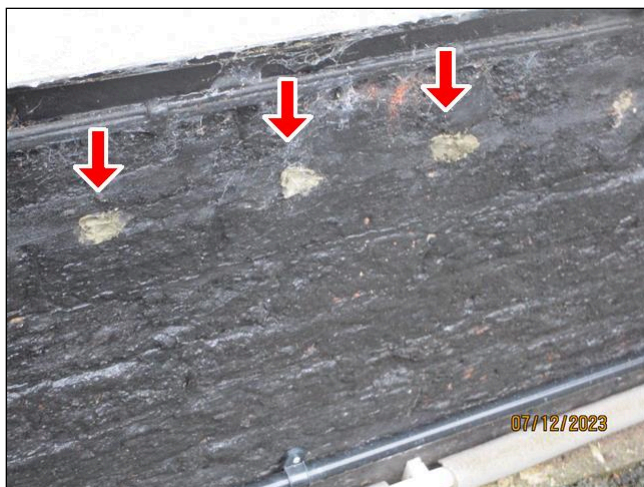
13.3 Item 1(Picture) DPC should have guarantee

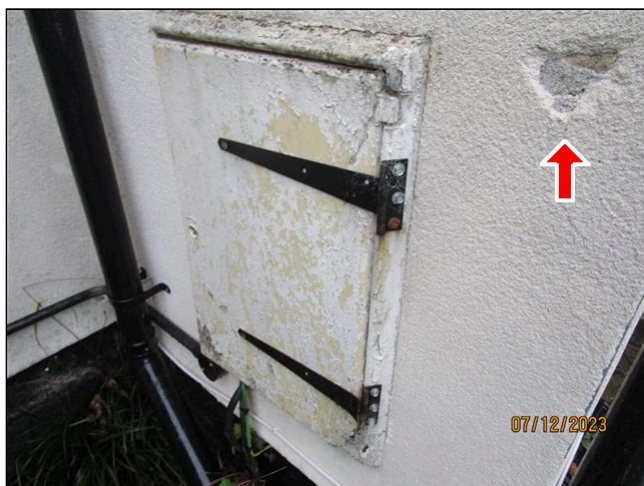
13.3 Item 3(Picture) Damage to wall render

Damaged sections should be repaired.

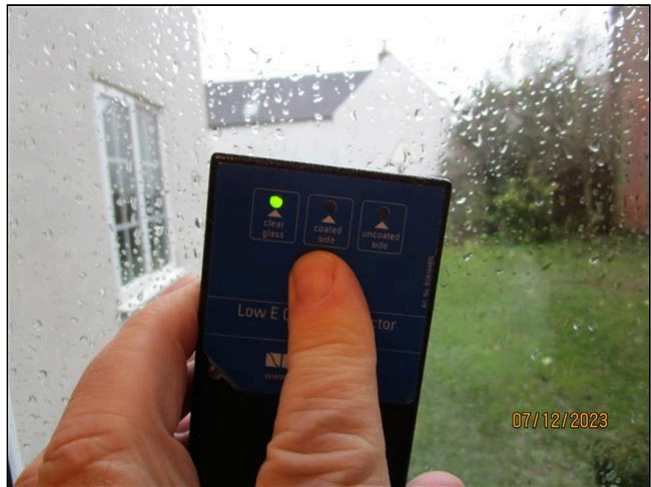
14.3 Item 4(Picture) Windows were fitted pre 2002

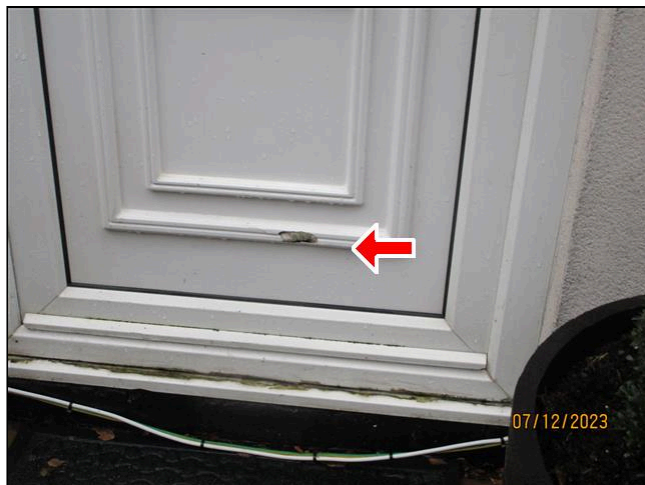
14.3 Item 5(Picture) Damage to the front door

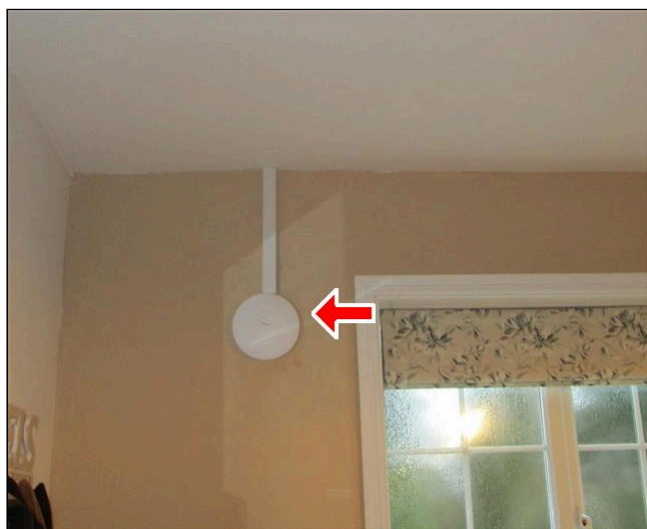
I noted some raised condensation risks to the Kitchen and the Bathroom and these are likely due to the Bathroom vent being switched off and these walls are colder than other walls. No visible mould or staining was noted at the time of inspection.

This increases the levels of moisture within the room and hence increases the risk of condensation to the walls and ceiling structures.

24.0 Item 1(Picture) Vent in the Bathroom was switched off

It is strongly advisable to install an extraction fan to improve ventilation.

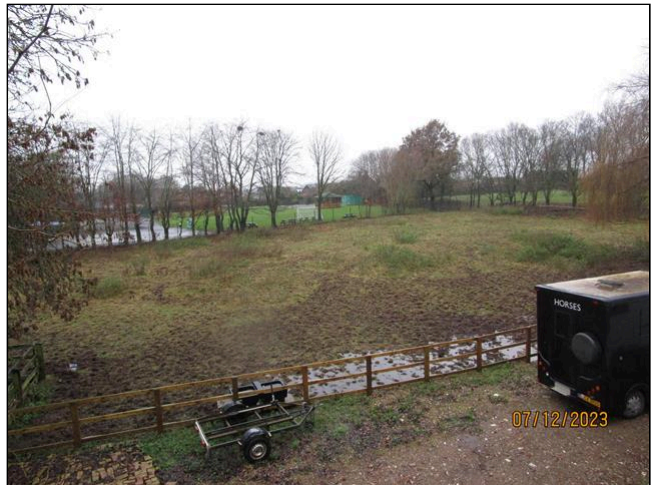
27.0 Item 2(Picture) Field at the back is waterlogged in places.

Some drainage may be needed for the field.
