Building Survey

John Smith
1 Anystreet
Abytown
Anywhere
DN29 9AD

Date: 07/12/2023**Report ID:** 8265A**Property:**1 Anystreet
Abytown
Anywhere NOT DN29 9AD**Customer:**

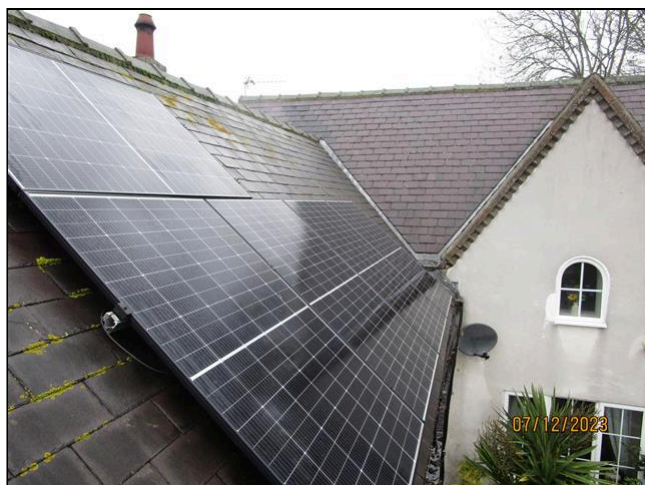
2.12 Renewable Energy Services

2.12 Item 1(Picture) PV Panels

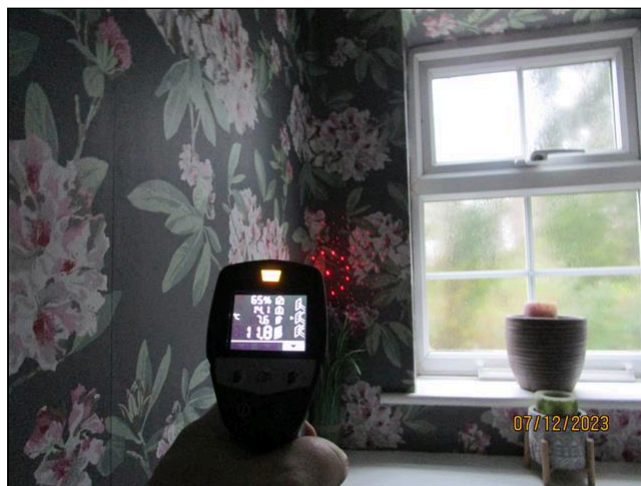
I noted some raised condensation risks to the Kitchen and the Bathroom and these are likely due to the Bathroom vent being switched off and these walls are colder than other walls. No visible mould or staining was noted at the time of inspection.

3.2 Item 4(Picture) Some elevated condensation readings

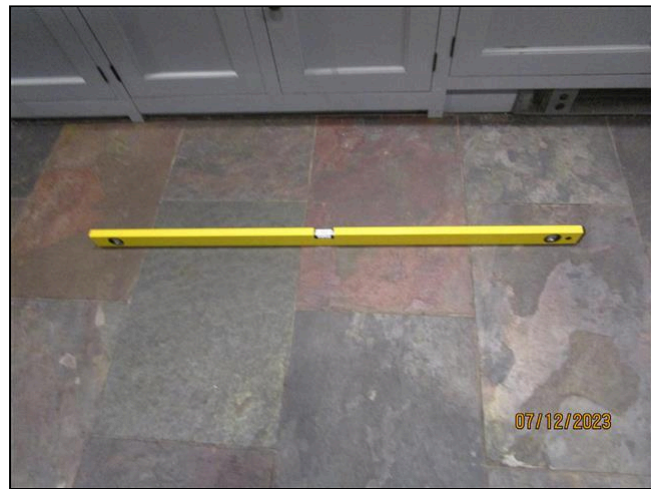
3.3 Item 4(Picture) Movement checks to floors

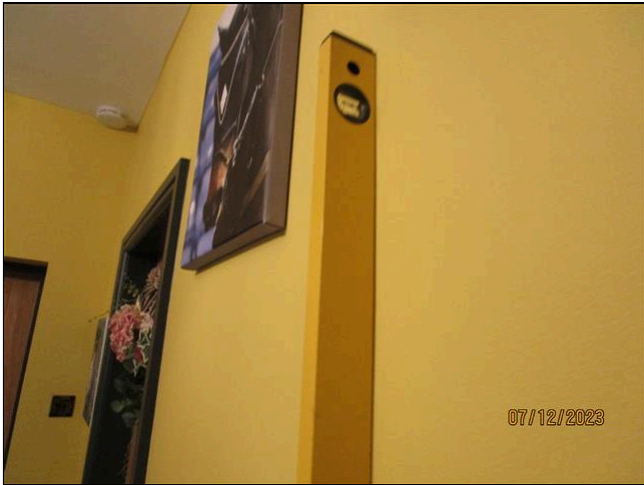
3.3 Item 5(Picture) Internal movement checks

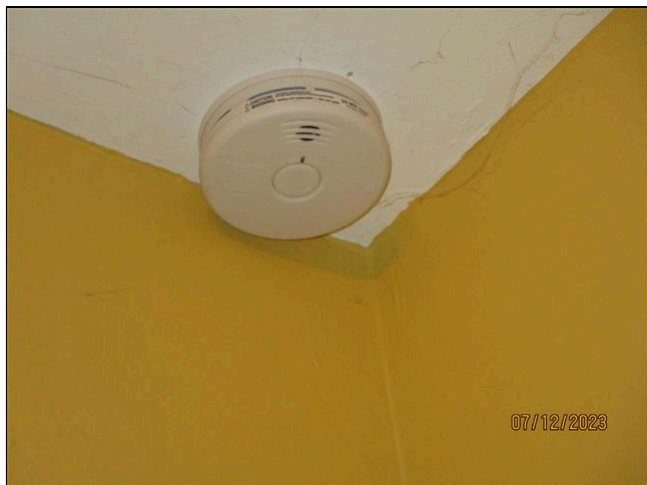
7.0 Item 1(Picture) Smoke alarm not tested

These should be tested on an annual basis.

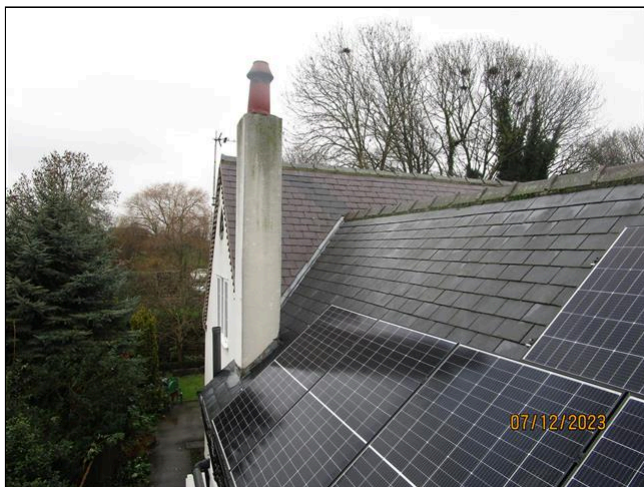
9.0 Item 2(Picture) Brick chimney with cement render

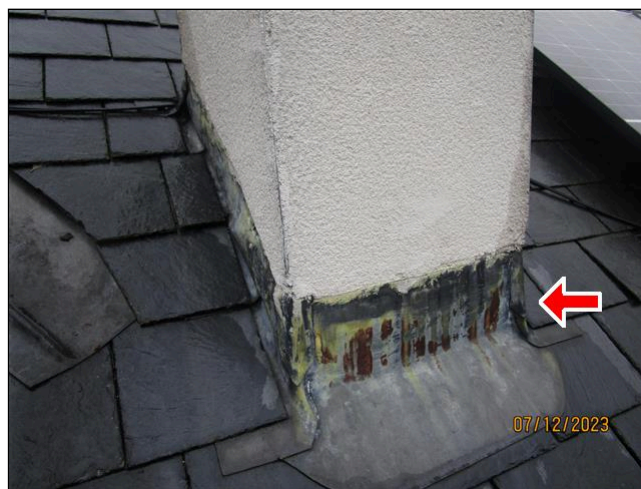
The flashing at the base of the stacks at the junction with the roof slopes is of lead.

9.3 Item 2(Picture) Lead flashing at the base

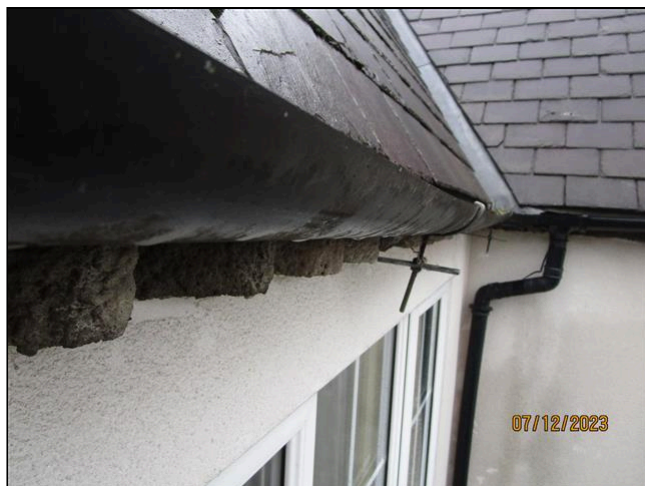
11.3 Item 1(Picture) Gutter fittings and downpipe

If it is noted during any heavy rain, that gutters or pipe joints are leaking, then these must be fixed as soon as possible to prevent water penetration to the property and possible damage to the foundations.

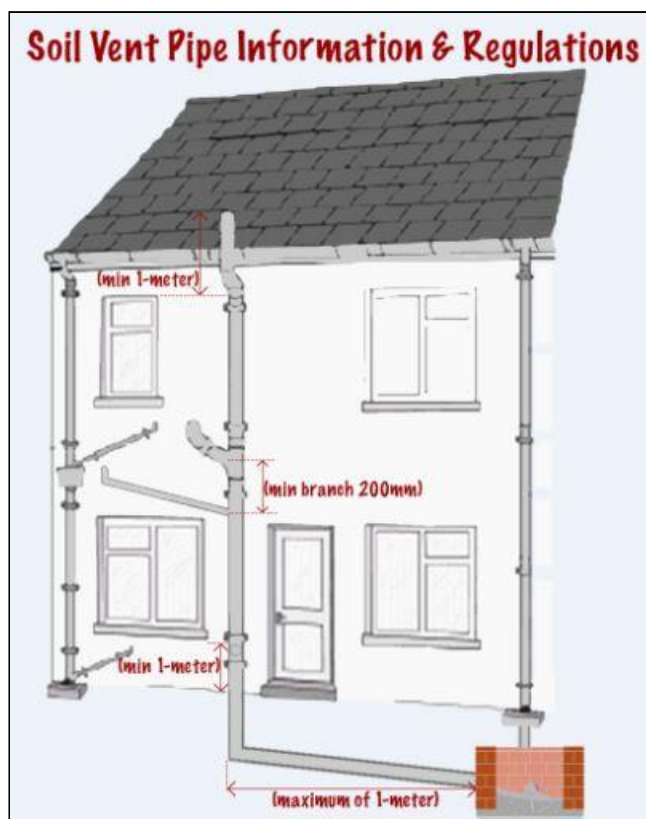
The pipes of the foul drainage system that are above ground (waste, soil & vent pipes) are of plastic types.

12.0 Item 1(Picture) Soil pipe system

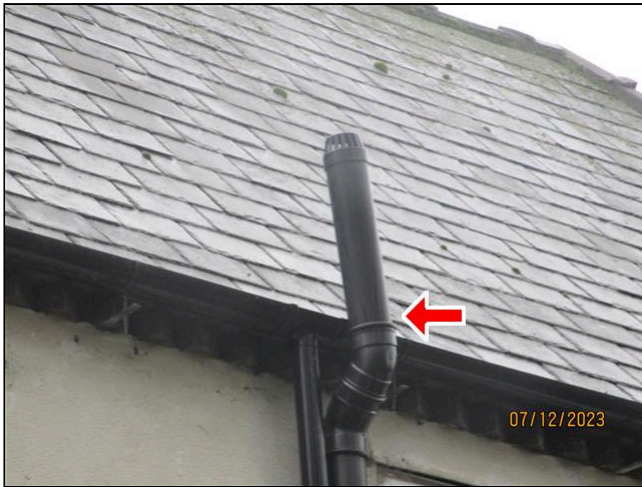
12.3 Item 1(Picture) Soil vent pipe at the rear

Soil pipes and vent stack, should be cleaned and inspected regularly to ensure that they are free from blockages and leaks.

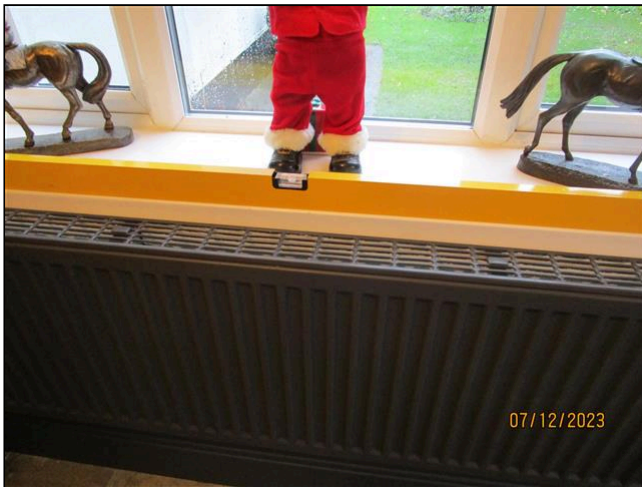
14.3 Item 3(Picture) Window level checks

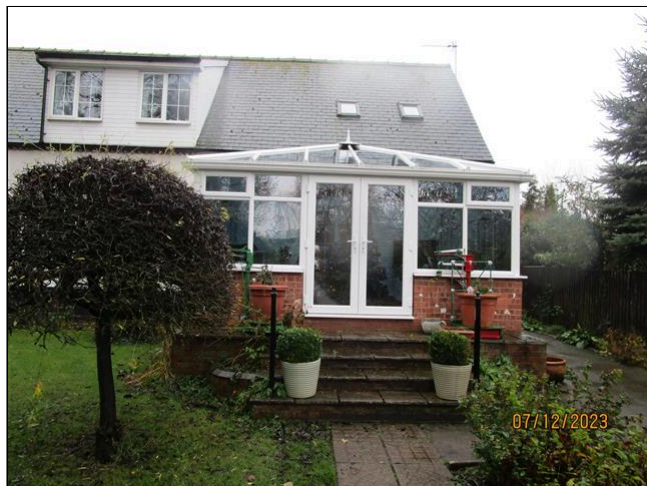
15.0 Item 1(Picture) Conservatory at the rear

The Conservatory is in a satisfactory condition with no signs of damp or movement noted at the time of inspection.

No significant defects are noted to the structure and normal maintenance is required.

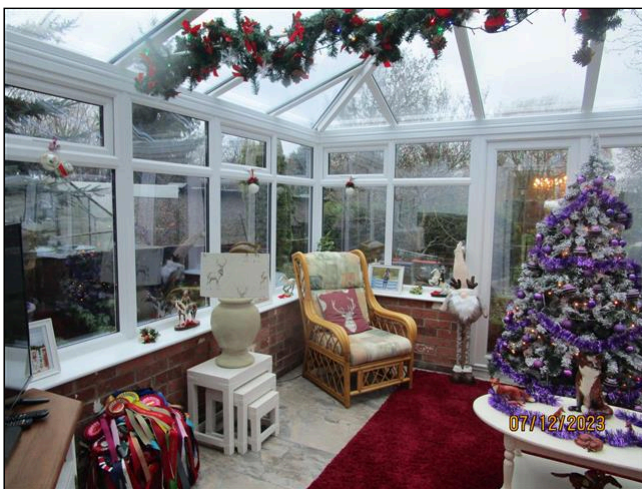
I checked the Conservatory walls for any damp along with the wall where the roof meets the main house. No signs of damp or leaks were noted.

15.3 Item 2(Picture) Inside the Conservatory

15.3 Item 3(Picture) Internal of the Conservatory

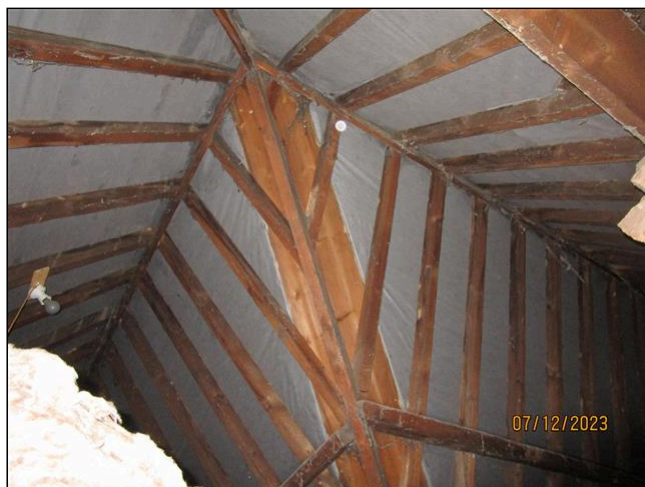
16.0 Item 1(Picture) Roof construction

The roof structure is in a satisfactory condition with reasonable quality timbers throughout.

The rafters, purlins and strut timbers seen were complete with no evidence of any undue stress or cracking.

You should refrain from storing items as this can disrupt the ventilation of the roof.

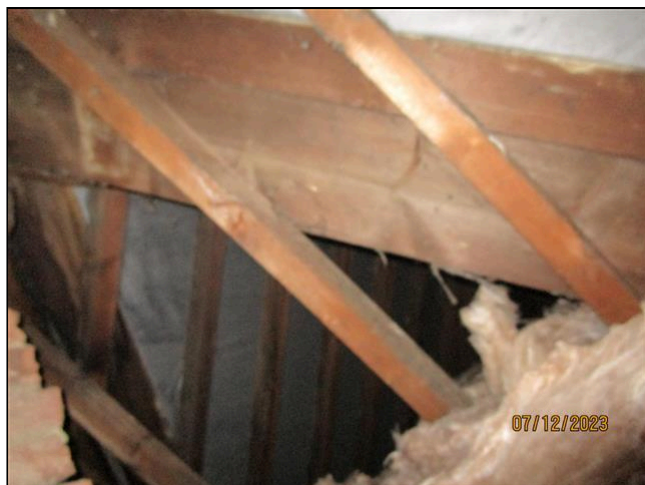
16.3 Item 1(Picture) Roof timbers

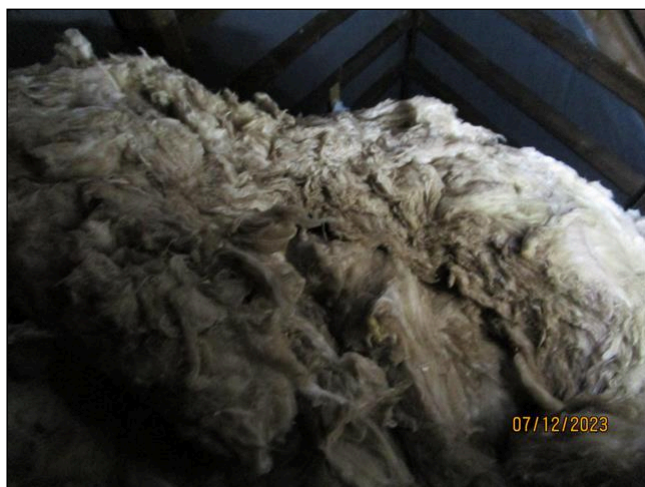
The insulation is at joist level and to a depth of about 250mm.

16.3 Item 3(Picture) Insulation

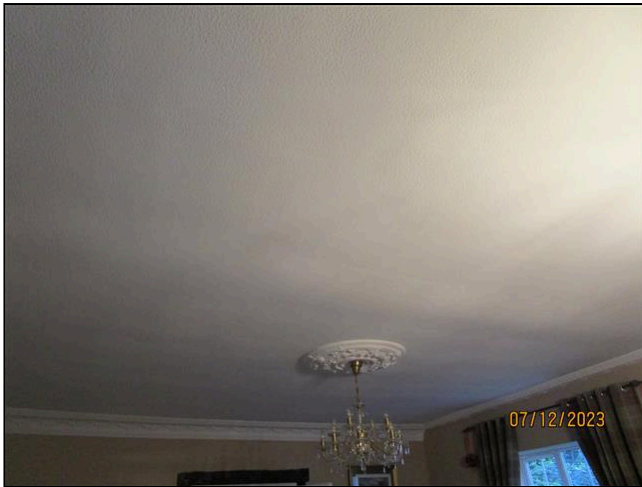
There was some visible hairline cracking to some plaster boarded areas along with perimeter junction cracking between the ceilings and walls in some places.

17.3 Item 1(Picture) Ceilings of likely timber lath

Normal future maintenance is required, including filling and redecorating any cracks as necessary.

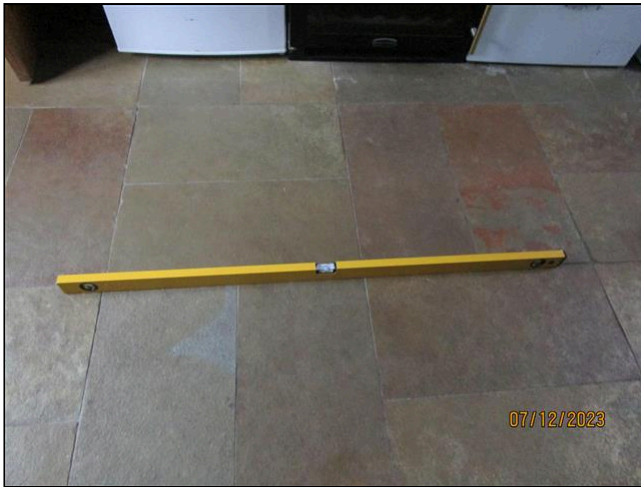
No undue levels of movement were noted at the time of the site inspection.

19.3 Item 1(Picture) Floor level checks

Floors should be monitored for any changes that occur in their level or springiness.

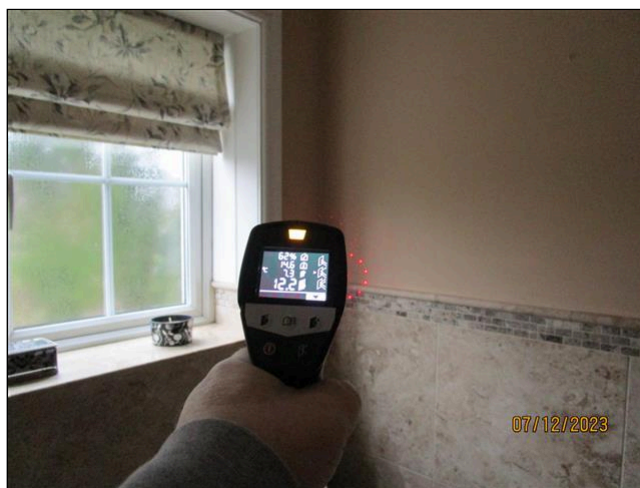
I noted some raised condensation risks to the Kitchen and the Bathroom and these are likely due to the Bathroom vent being switched off and these walls are colder than other walls.

24.0 Item 2(Picture) Elevated condensation readings in Bathroom

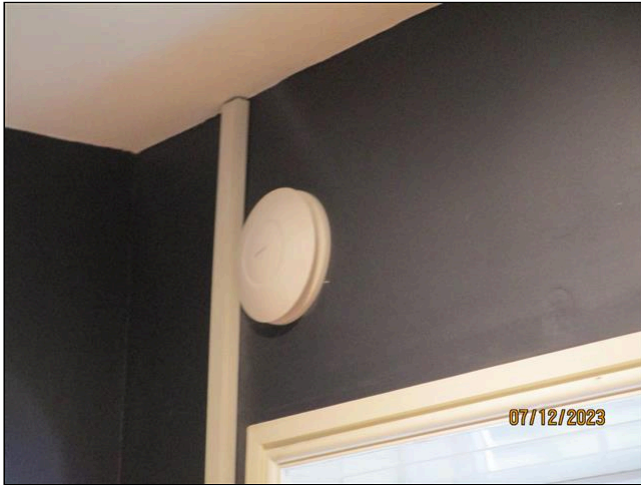
There is mechanical extraction ventilation to the Kitchen areas. This should be checked regularly to ensure always operational.

24.1 Item 1(Picture) Kitchen vent near window

These fans must be used at all times.

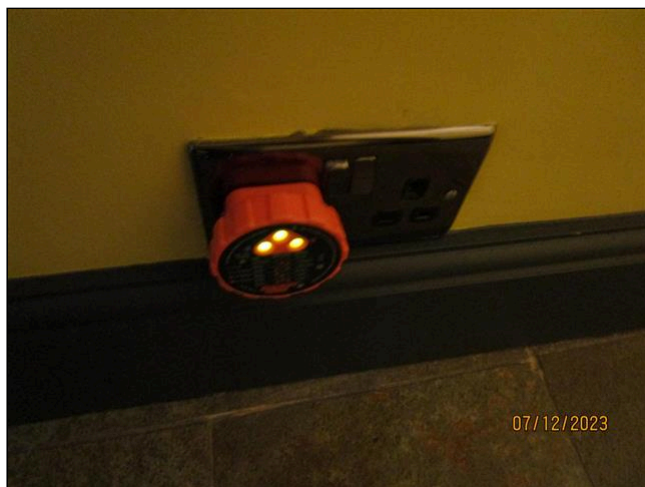
29.0 Item 3(Picture) Electric socket tests

In general the electrical circuits seen, are in a satisfactory condition. PVC cabling was observed at the property and the socket face plates and switch plates are of a suitable modern quality.

The electrical system should have a full safety check carried out (if there is not one in place) and any recommendations should be implemented.

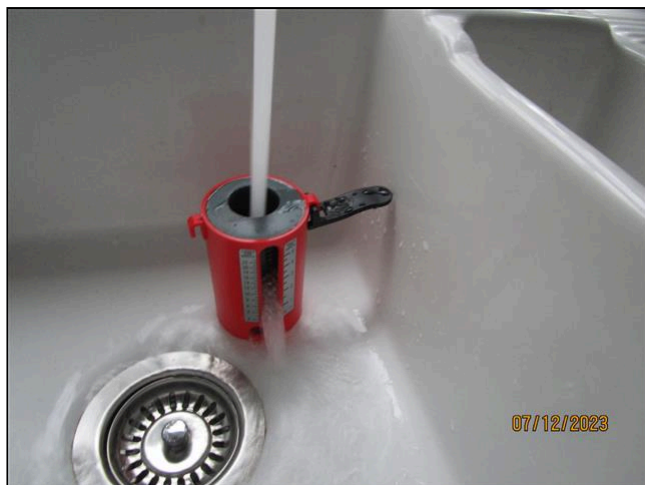
30.0 Item 1(Picture) Water flow checks

No significant defects are noted at the time of the site inspection, all fittings operated as required with water pressures at a satisfactory level.

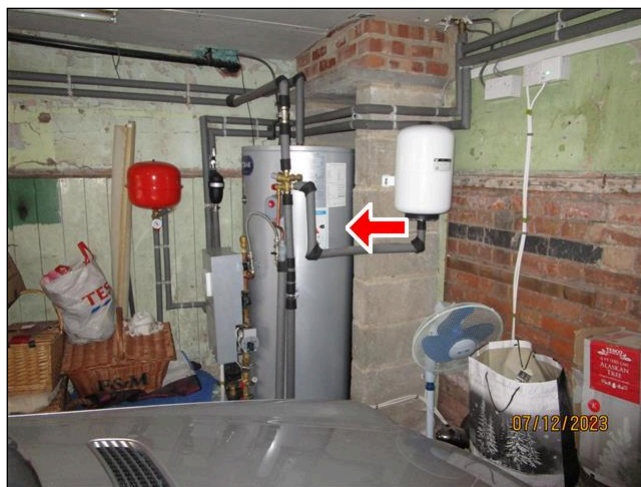
31.3 Item 2(Picture) New Hot Water Tank in the garage

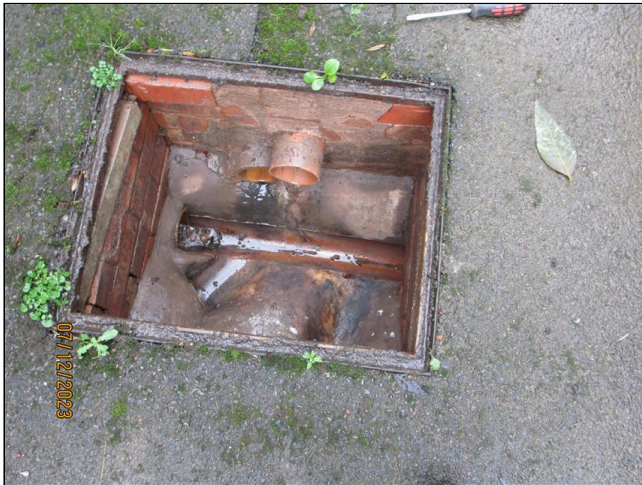
32.3 Item 1(Picture) Drain running clear

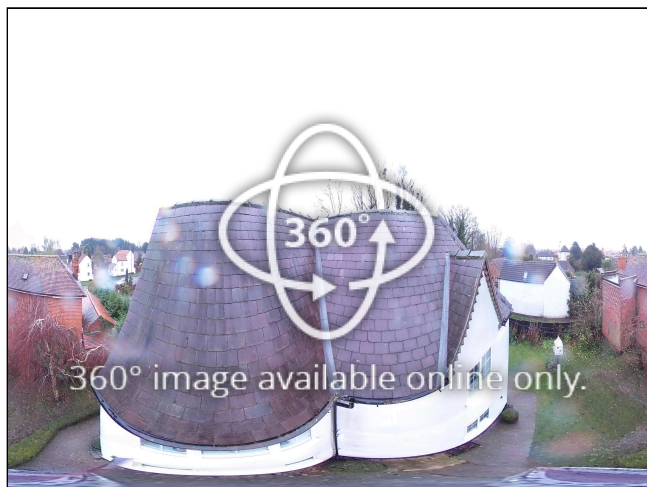
35.0 Item 2(Picture) Front side roof

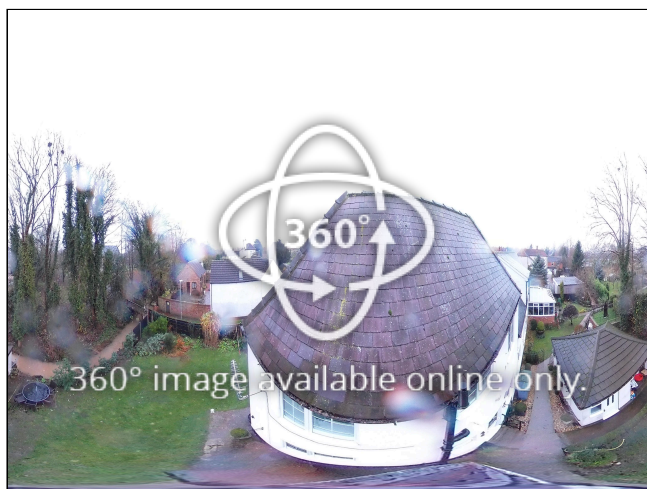
35.0 Item 3(Picture) Rear roof

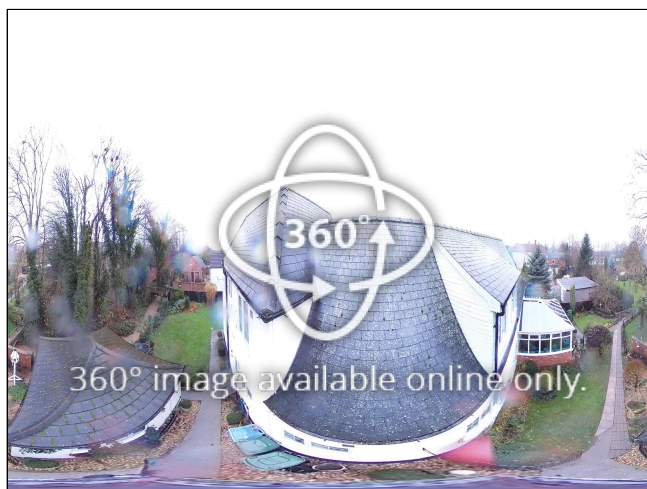
35.0 Item 4(Picture) Rear roof

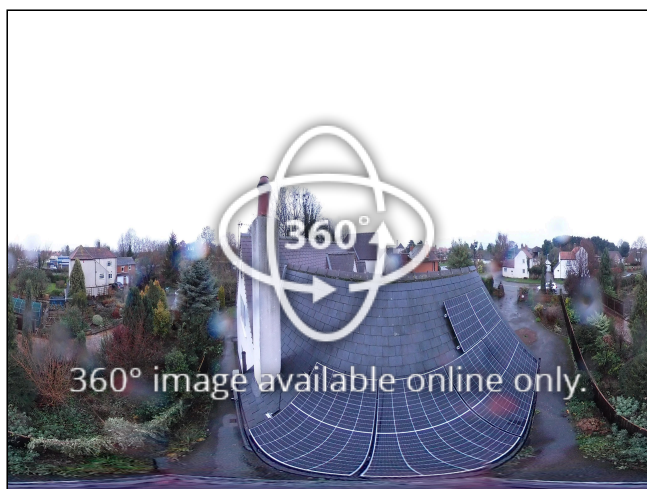
35.0 Item 5(Picture) Left side roof
