Building Survey

John Smith
1 Anystreet
Abytown
Anywhere
DN29 9AD

Date: 07/12/2023**Report ID:** 8265A**Property:**1 Anystreet
Abytown
Anywhere NOT DN29 9AD**Customer:**

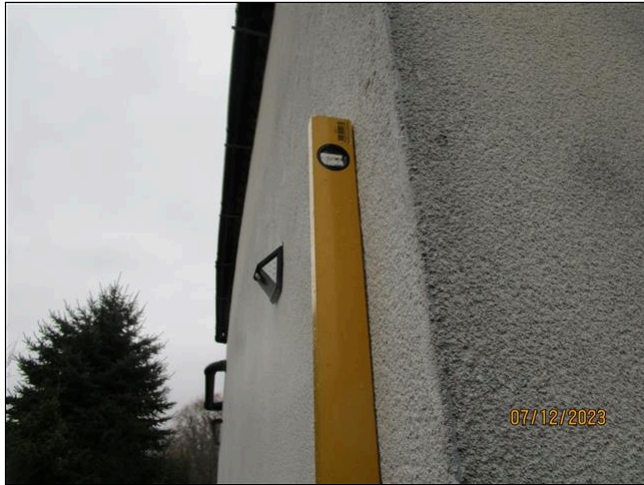
3.3 Item 1(Picture) External movement checks

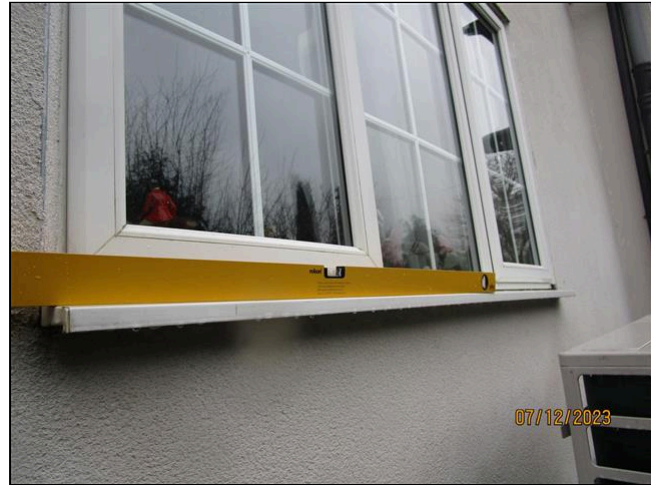
3.3 Item 2(Picture) Checks to external openings

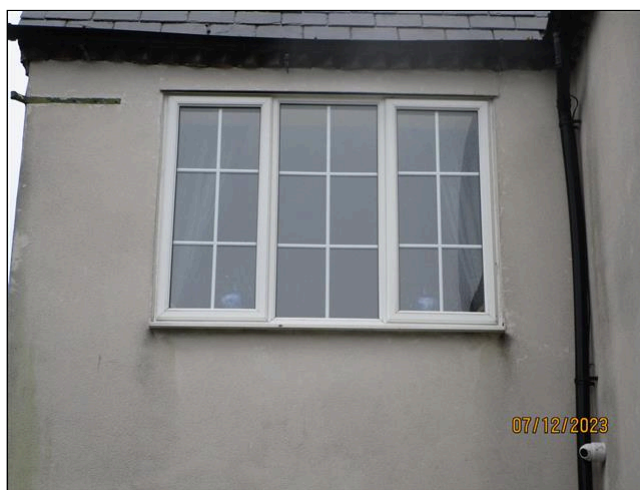
The windows are UPVC frames with sealed unit double glazing.

14.0 Item 2(Picture) uPVC double glazed windows

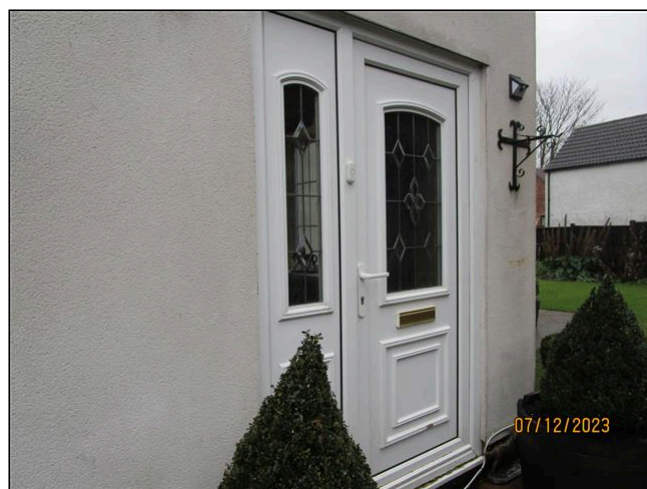
14.0 Item 3(Picture) External doors

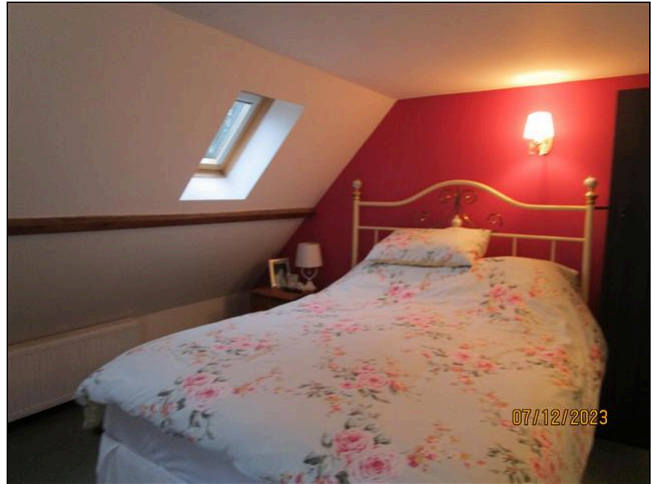
14.3 Item 2(Picture) Velux windows

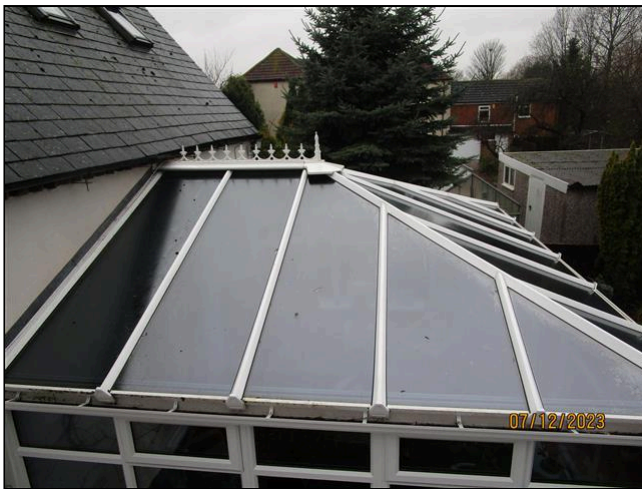
Whilst it was dry at the time of inspection there were no signs of leaks to the roof structure.

15.3 Item 1(Picture) Conservatory roof

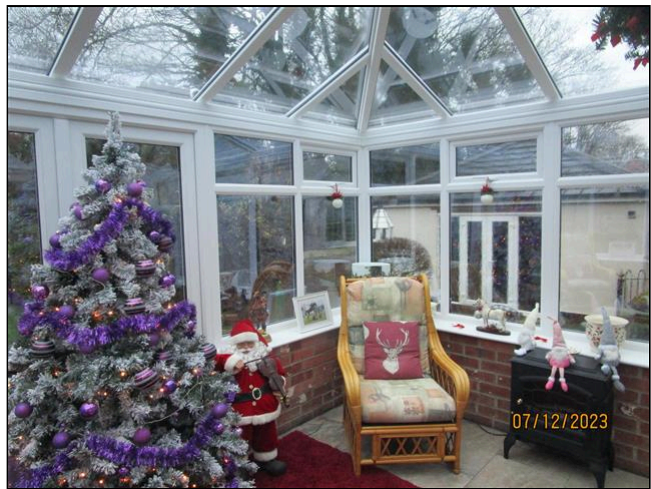
I checked the Conservatory walls for any damp along with the wall where the roof meets the main house. No signs of damp or leaks were noted.

15.3 Item 2(Picture) Inside the Conservatory

15.3 Item 3(Picture) Internal of the Conservatory

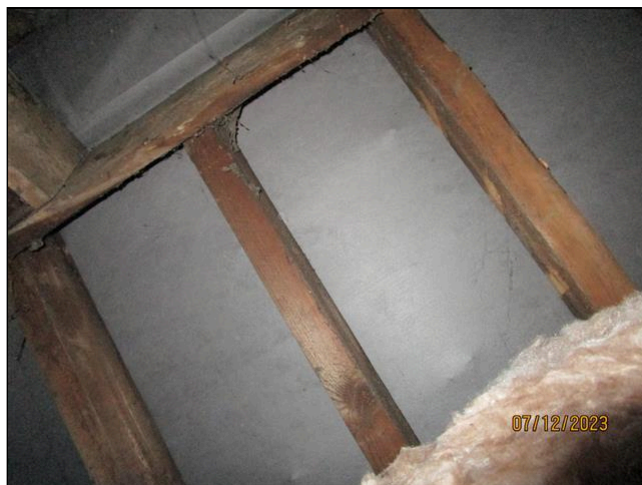
The breathable undercovering (secondary waterproof covering) is complete with no major tears or missing sections.

16.3 Item 2(Picture) Breathable undercovering

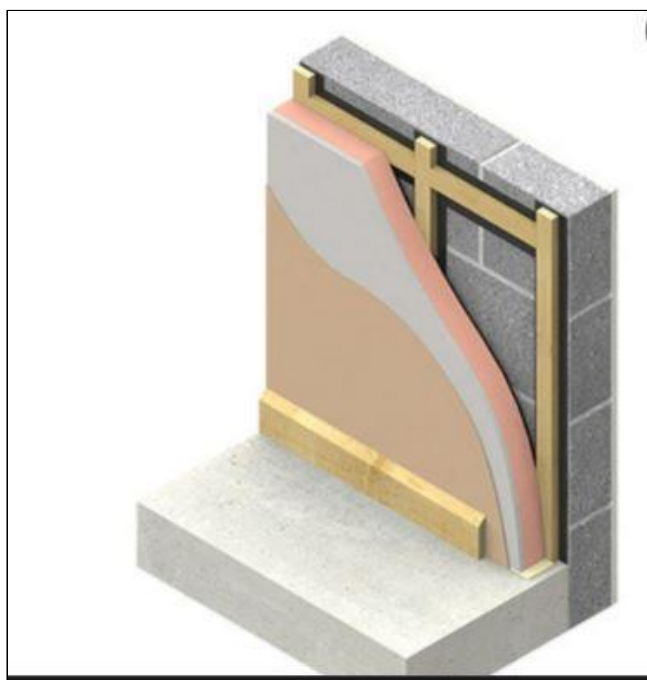
The internal faces to the external walls of the property have been insulated. The exceptions are the Kitchen, Utility Room (rear wall) and the Bathroom.

18.0 Item 1(Picture) Internal wall insulation

18.0 Item 2(Picture) Thermal Imagery showing insulation

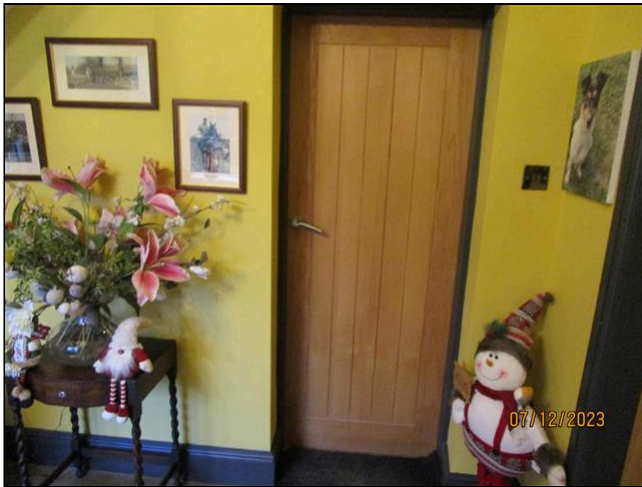
No significant defects or damage, other than age appropriate and from normal usage, was noted during the site inspection.

22.3 Item 1(Picture) Internal doors

The doors, stairs and other woodwork need normal maintenance including some redecoration.

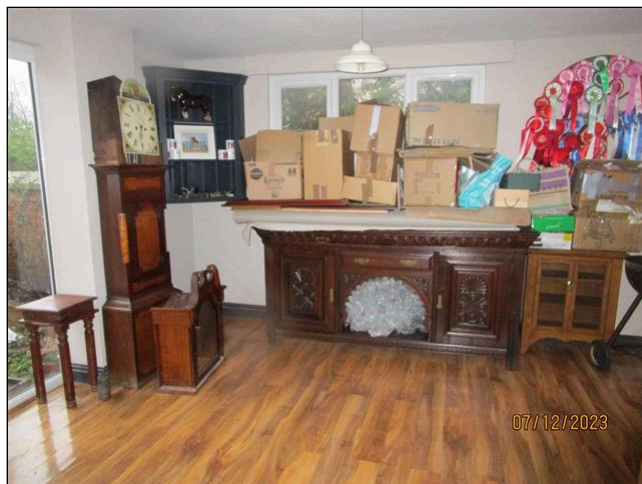
26.3 Item 2(Picture) Possessions in the Summerhouse

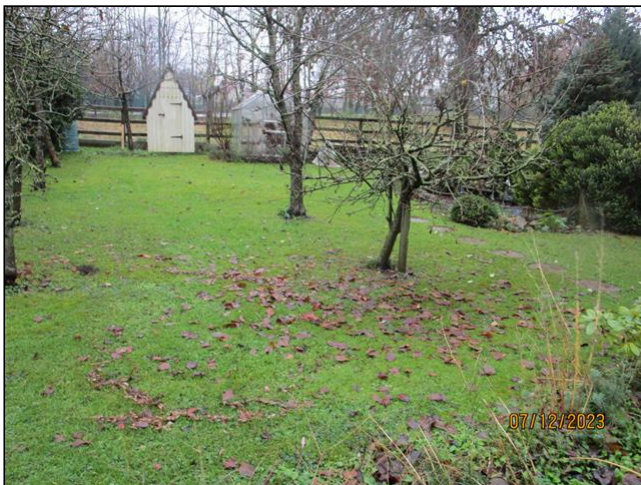
27.0 Item 3(Picture) Back garden

Some drainage may be needed for the field.
